ROUTE 58 CORRIDOR STUDY

INCLUDING THE COMMUNITIES OF: ABINGTON, WHITMAN,
HANSON, HALIFAX, AND PLYMPTON

OLD COLONY PLANNING COUNCIL

SEPTEMBER, 2010

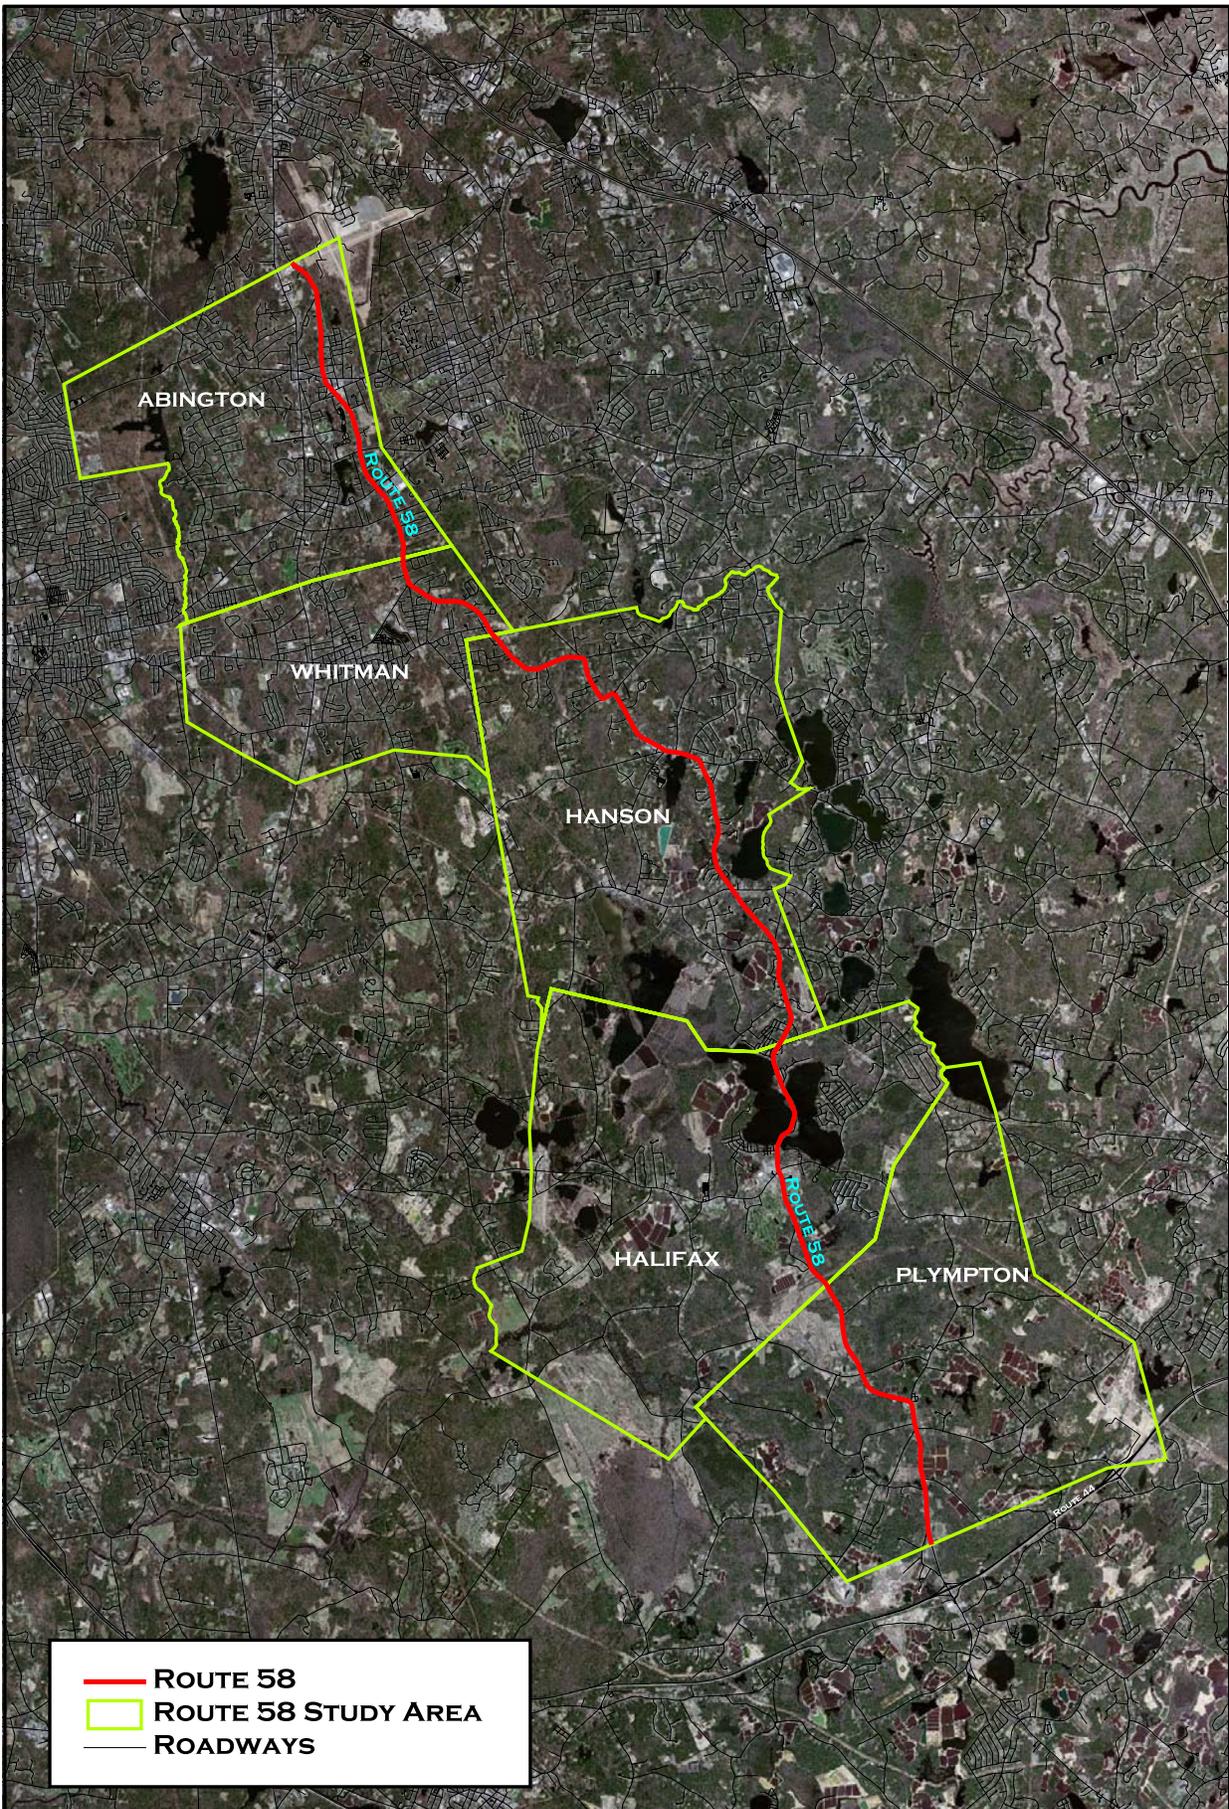
FIGURE 1

ROUTE 58 ORTHO PHOTO, 2008

Route 58 is classified as an urban minor arterial in Abington, Whitman, Hanson, and Halifax, and as a rural major collector in Plympton. It is under local town jurisdiction and is eligible for federal-aid funding. Figure 1 shows the geographic scope of the study area and the road classifications.

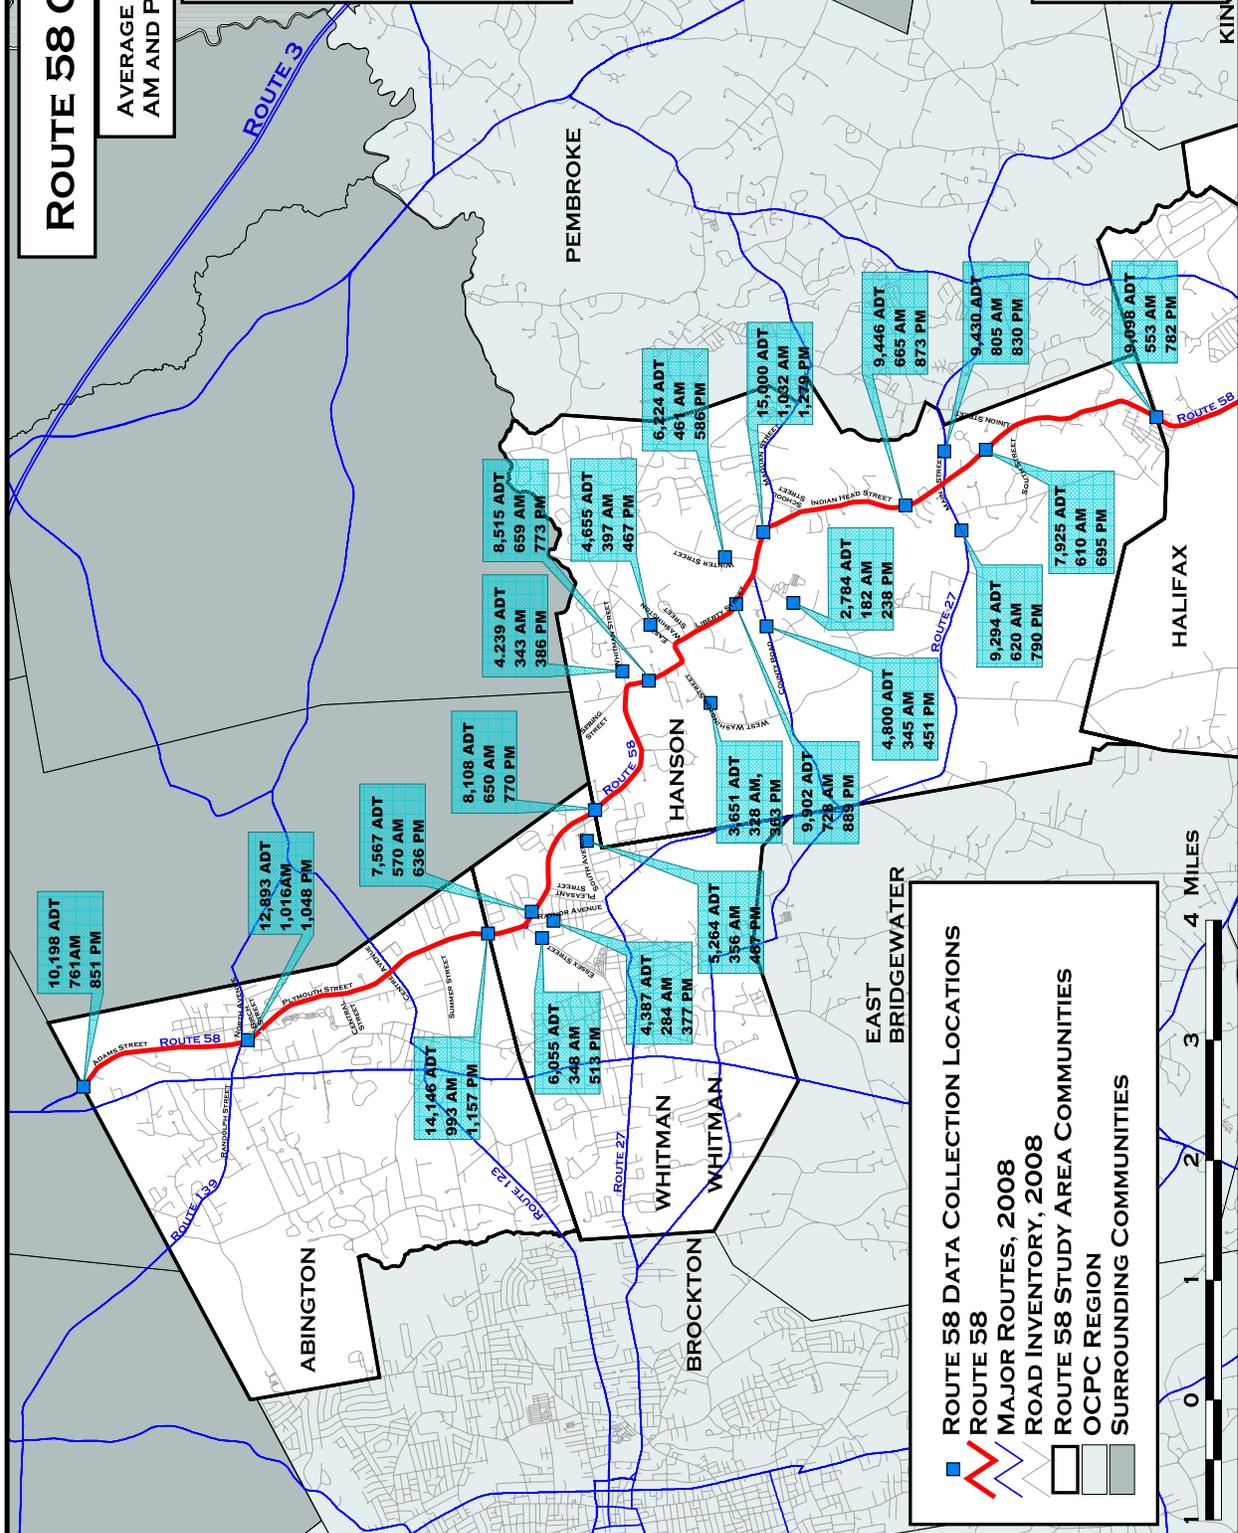
AVERAGE DAILY TRAFFIC (ADT) & AM AND PM PEAK

ROUTE 58 STUDY AREA

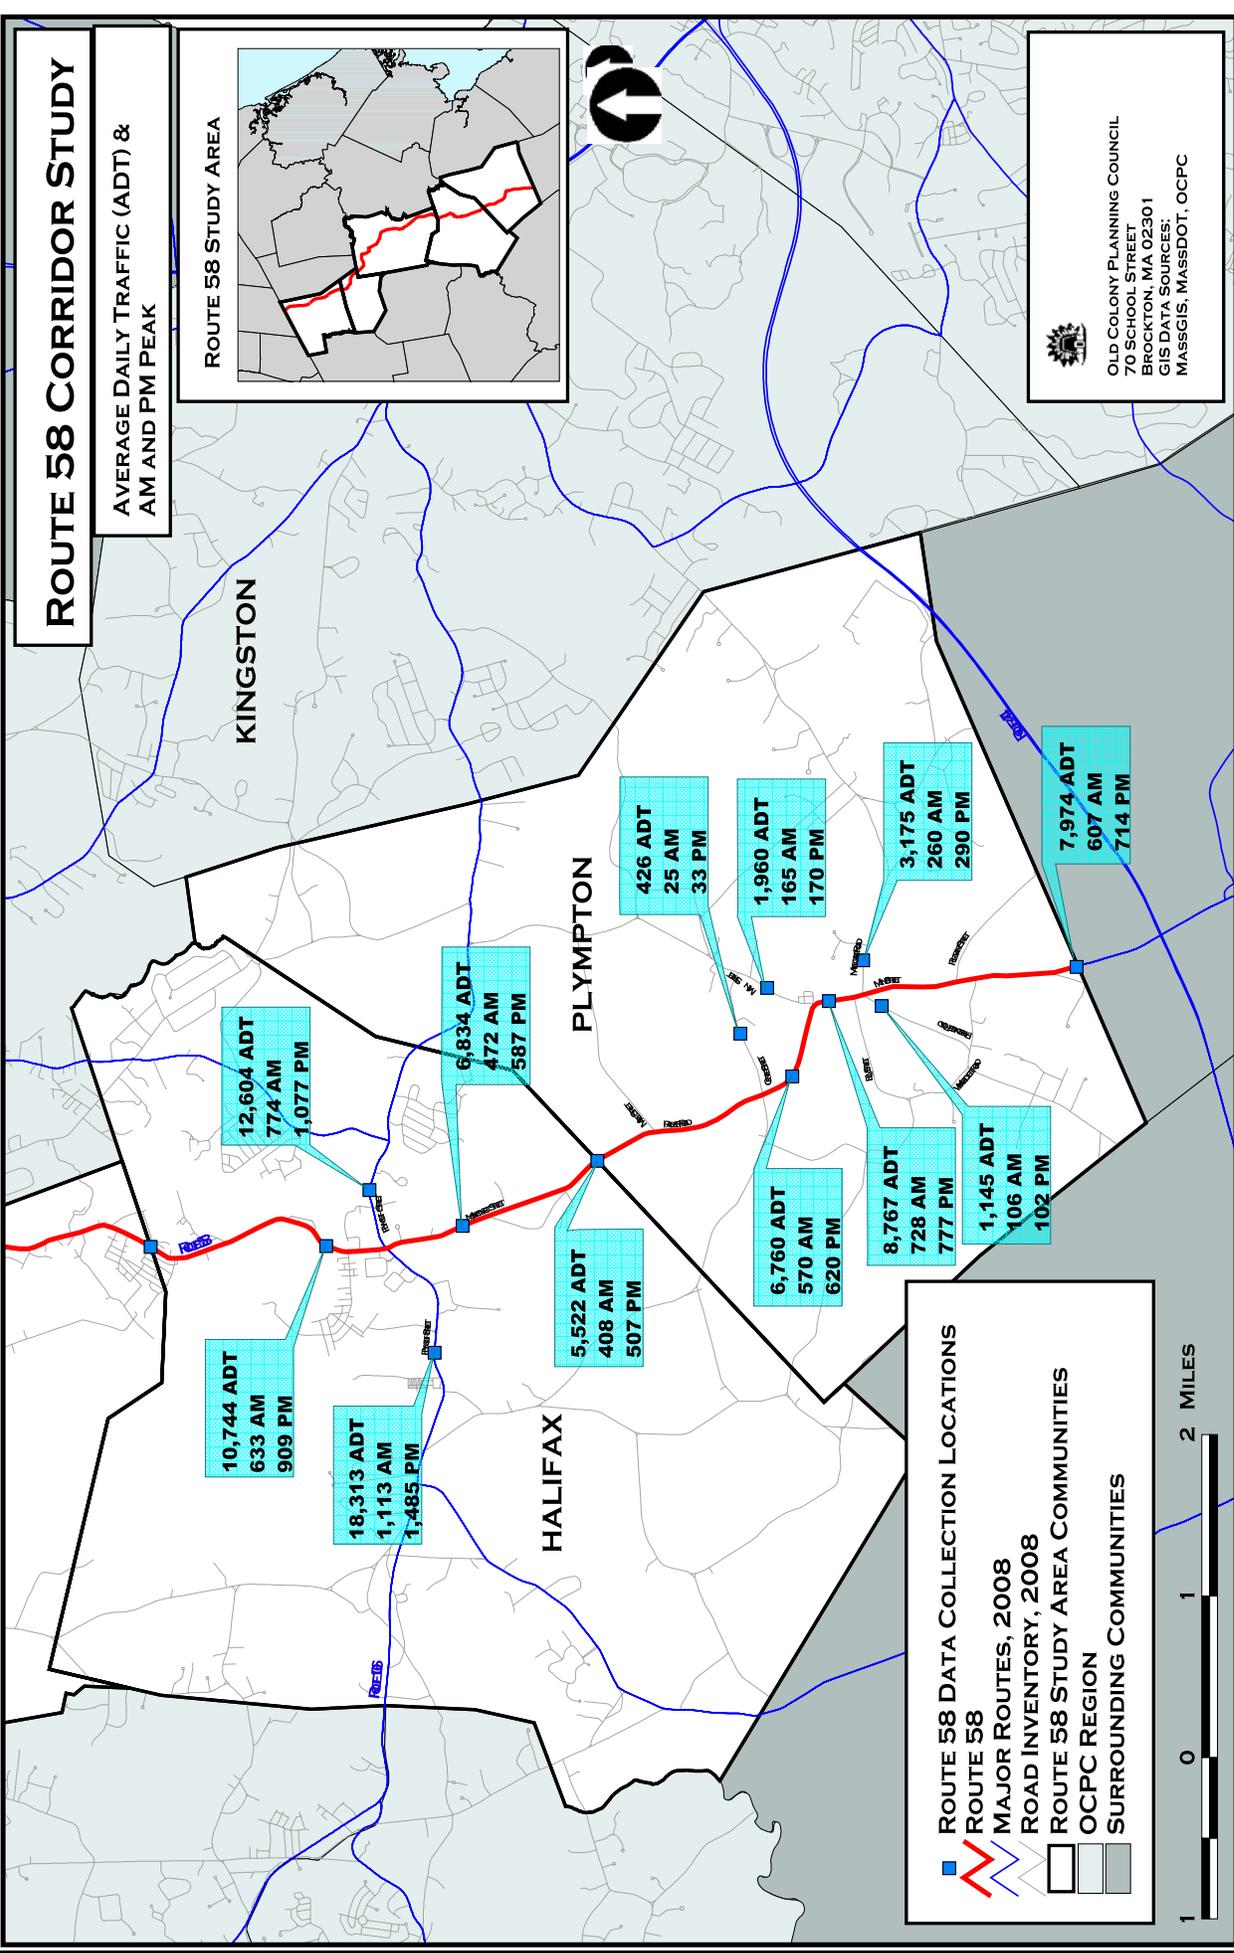
AVERAGE DAILY TRAFFIC (ADT) & AM AND PM PEAK

ROUTE 58 STUDY AREA

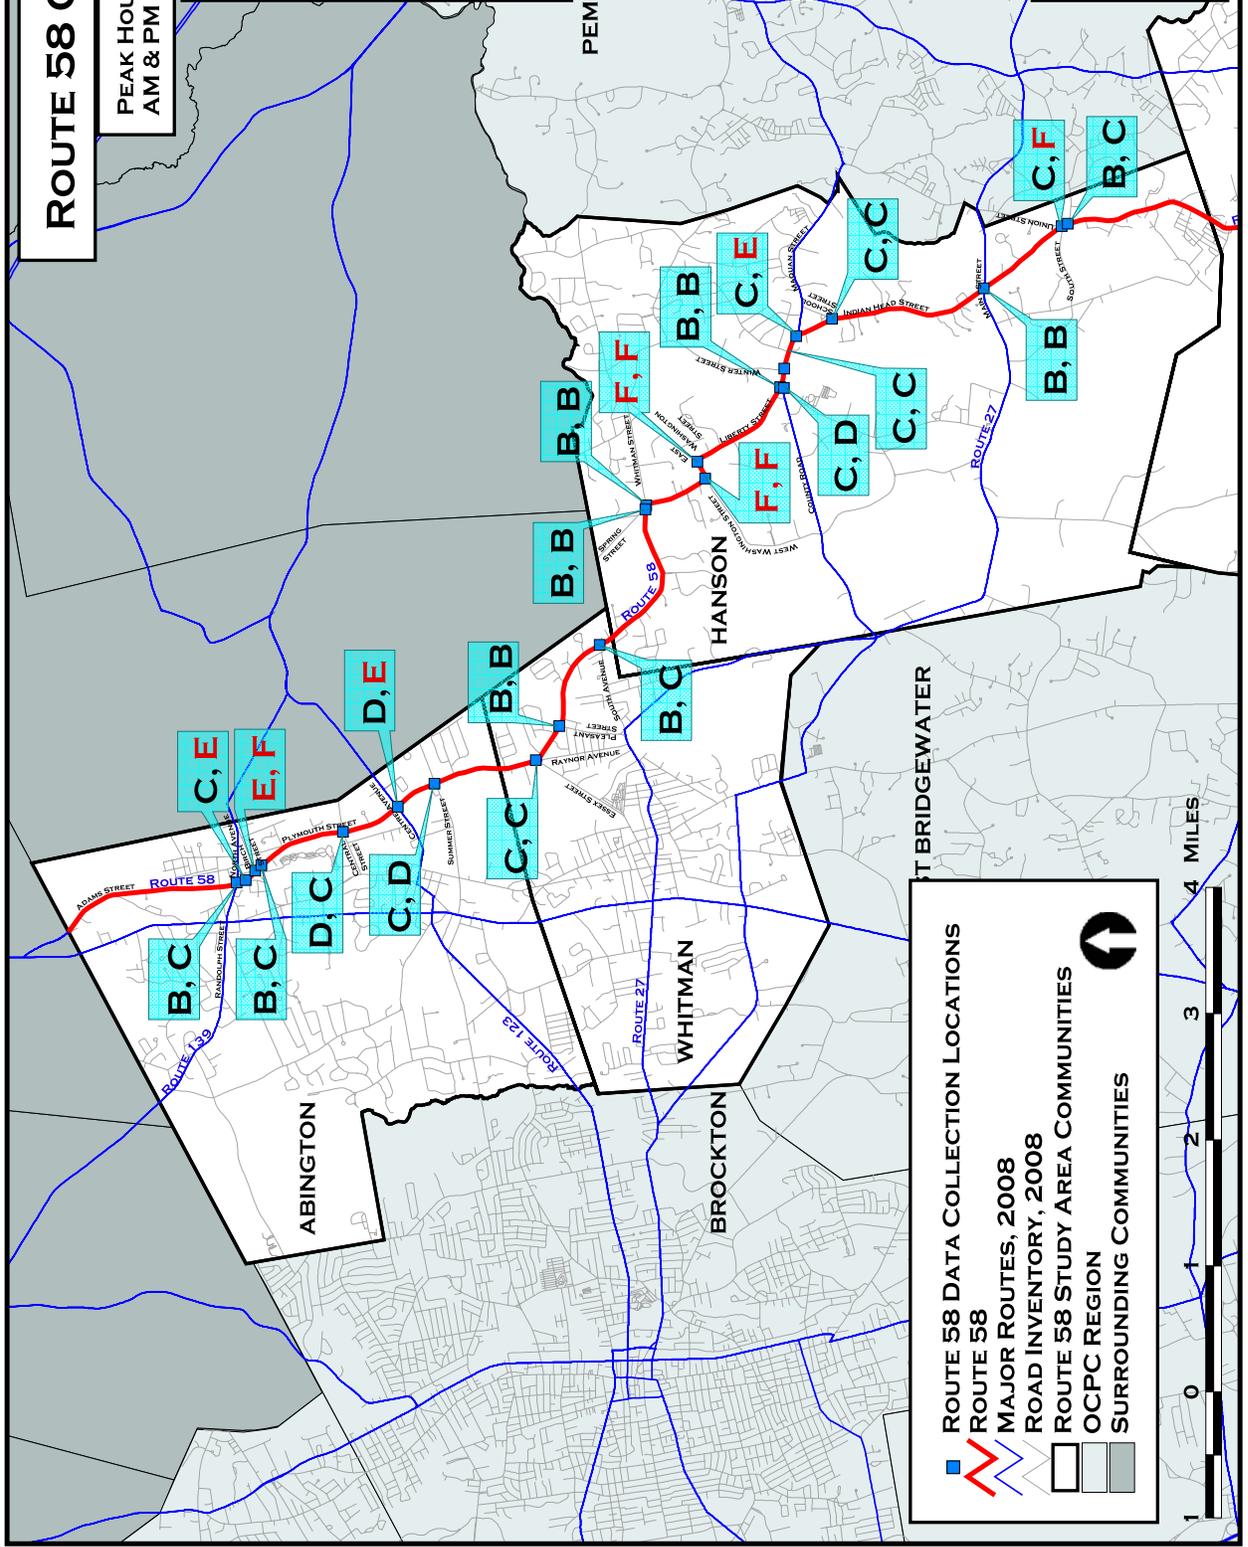
PEAK HOUR LEVELS OF SERVICE
AM & PM

ROUTE 58 STUDY AREA

Table 2 shows the signalized and unsignalized levels-of-service for the Route 58 study area intersections under existing peak hour conditions. Congestion at intersections in Table 2 (LOS “E” and “F”) is shown in shaded blocks.

Table 2 shows that 22 of the 30 study area intersections are stop sign controlled, and six of these stop sign intersections experience LOS “E” or “F” conditions during the morning peak hour, afternoon peak hour, or during both peak hours. Table 2, shows that seven of the study area intersections are signal controlled. Only one of these signalized intersections, Plymouth Street Route 58 at Centre Avenue Route 123 in Abington, experiences a poor LOS. This intersection experiences LOS “E” conditions during the afternoon peak hour.

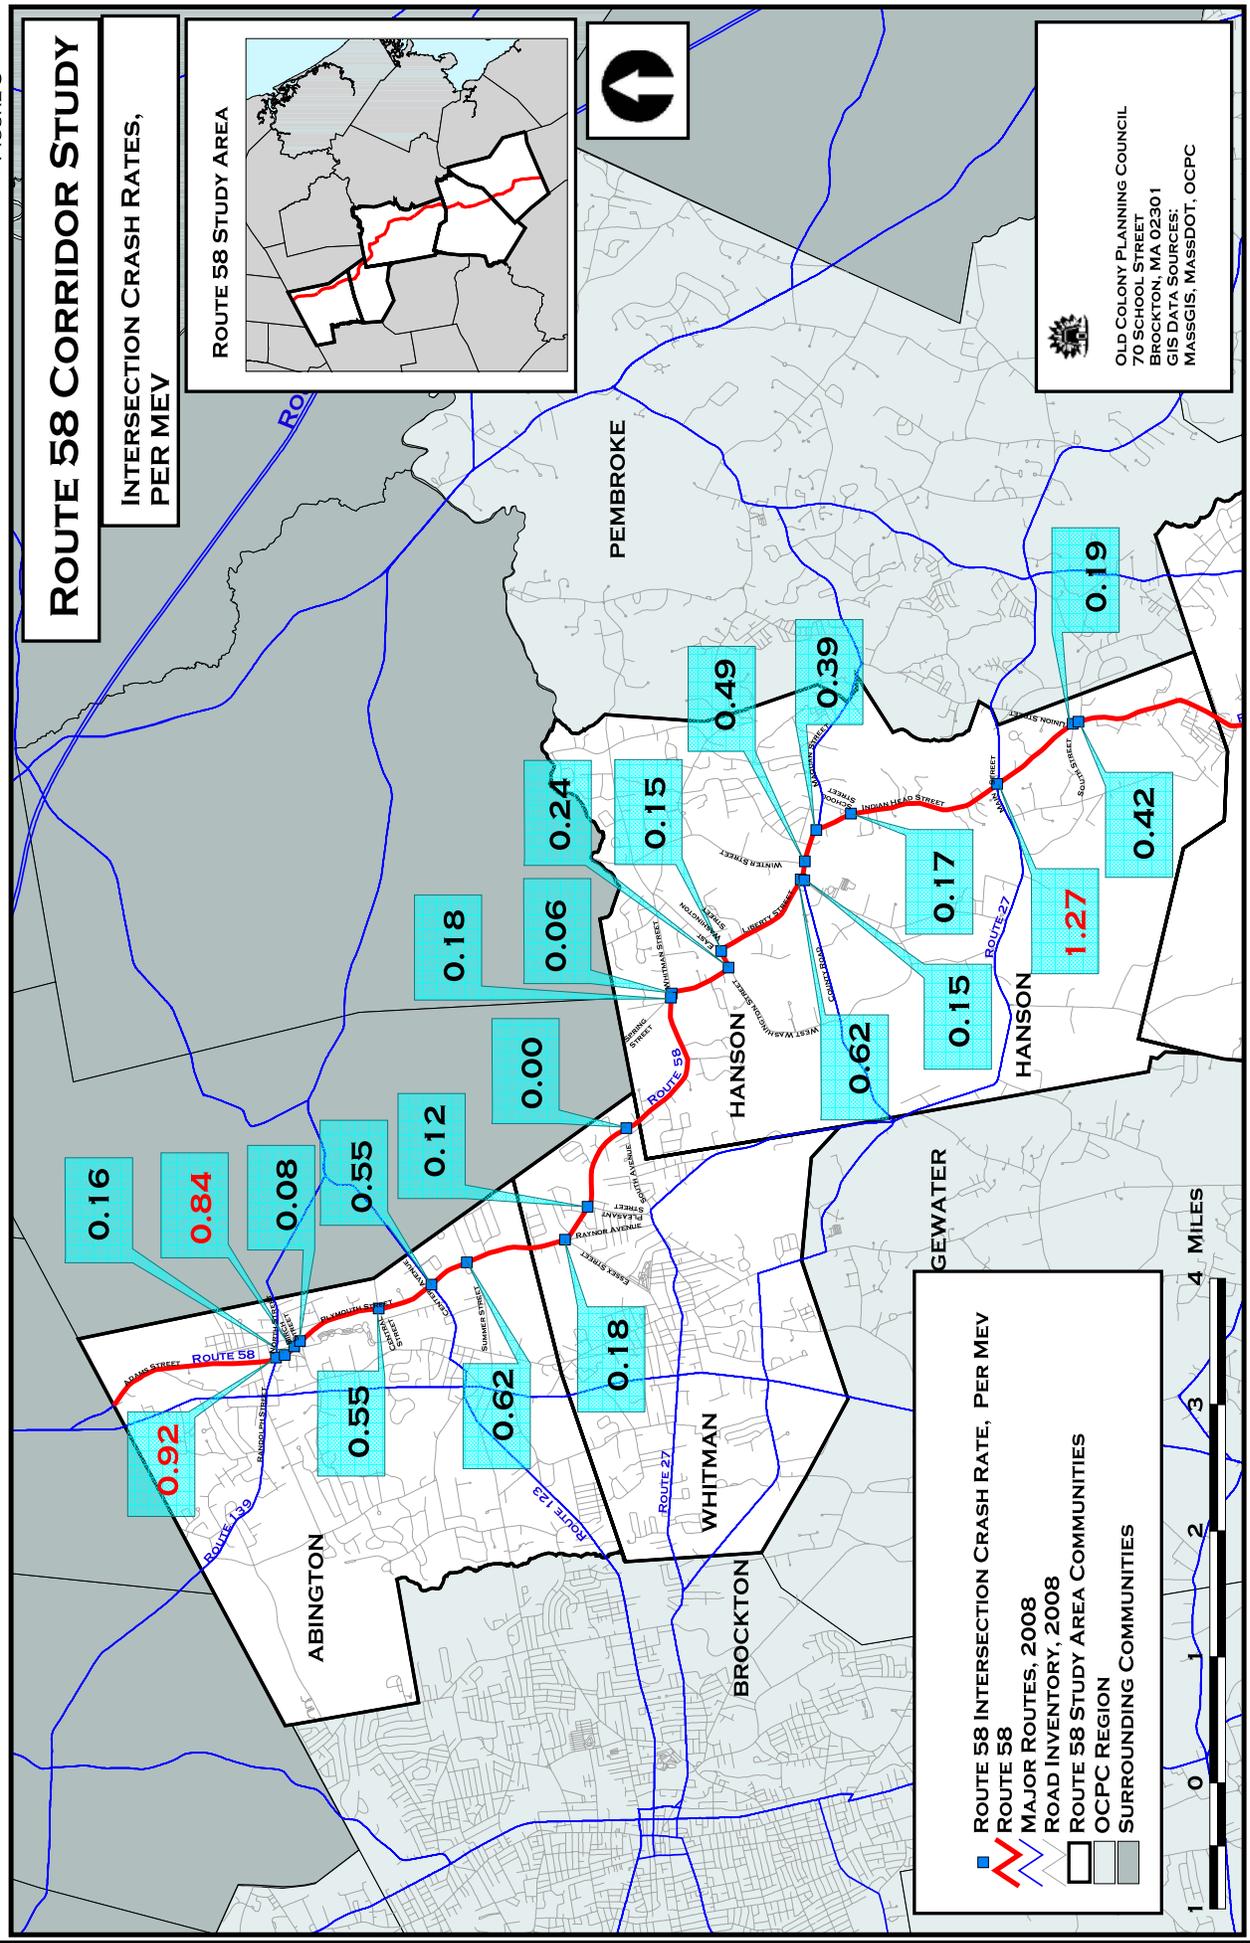
INTERSECTION CRASH RATES,
PER MEV

ROUTE 58 STUDY AREA

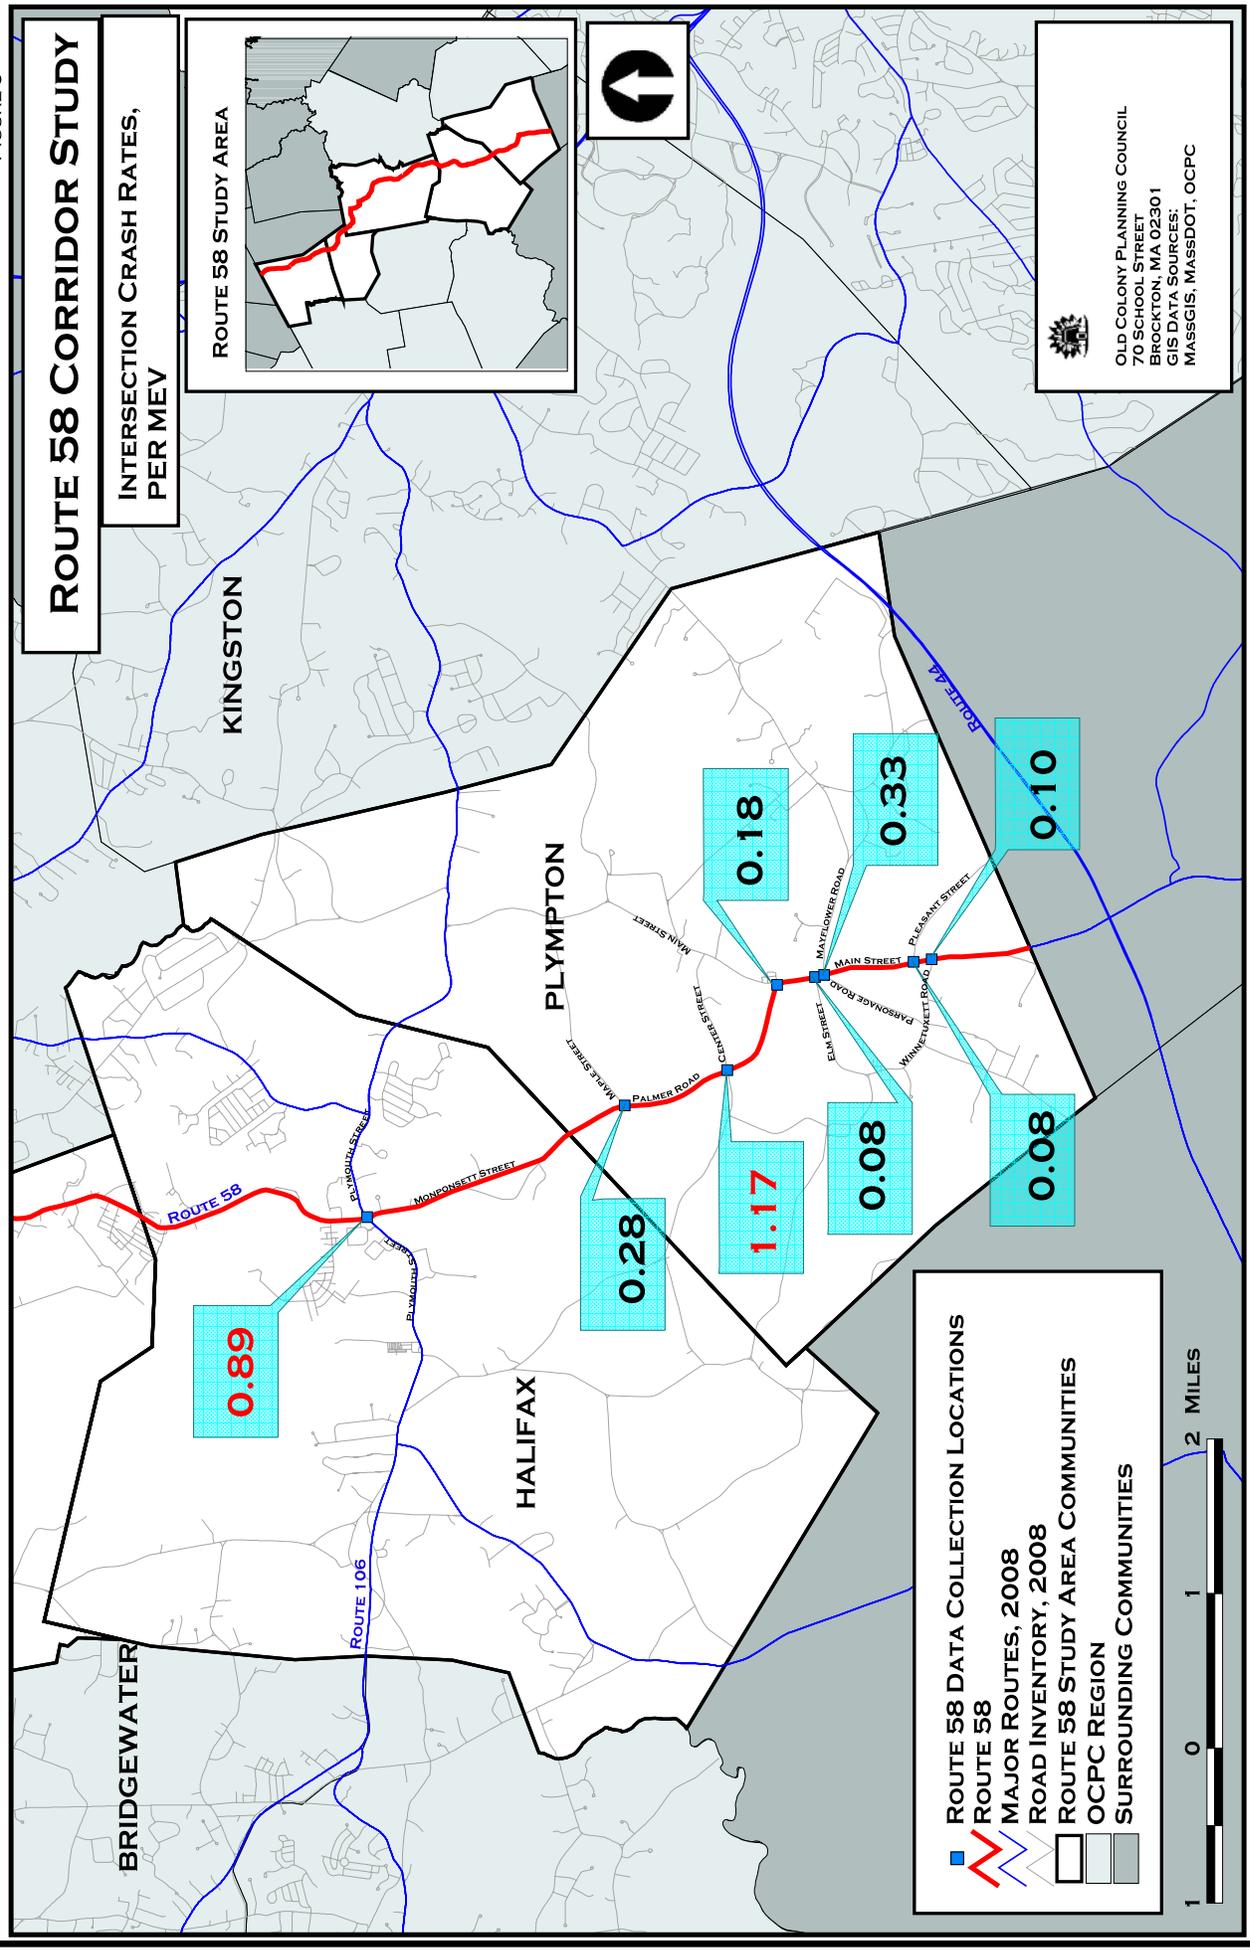
INTERSECTION CRASH RATES,
PER MEV

ROUTE 58 STUDY AREA

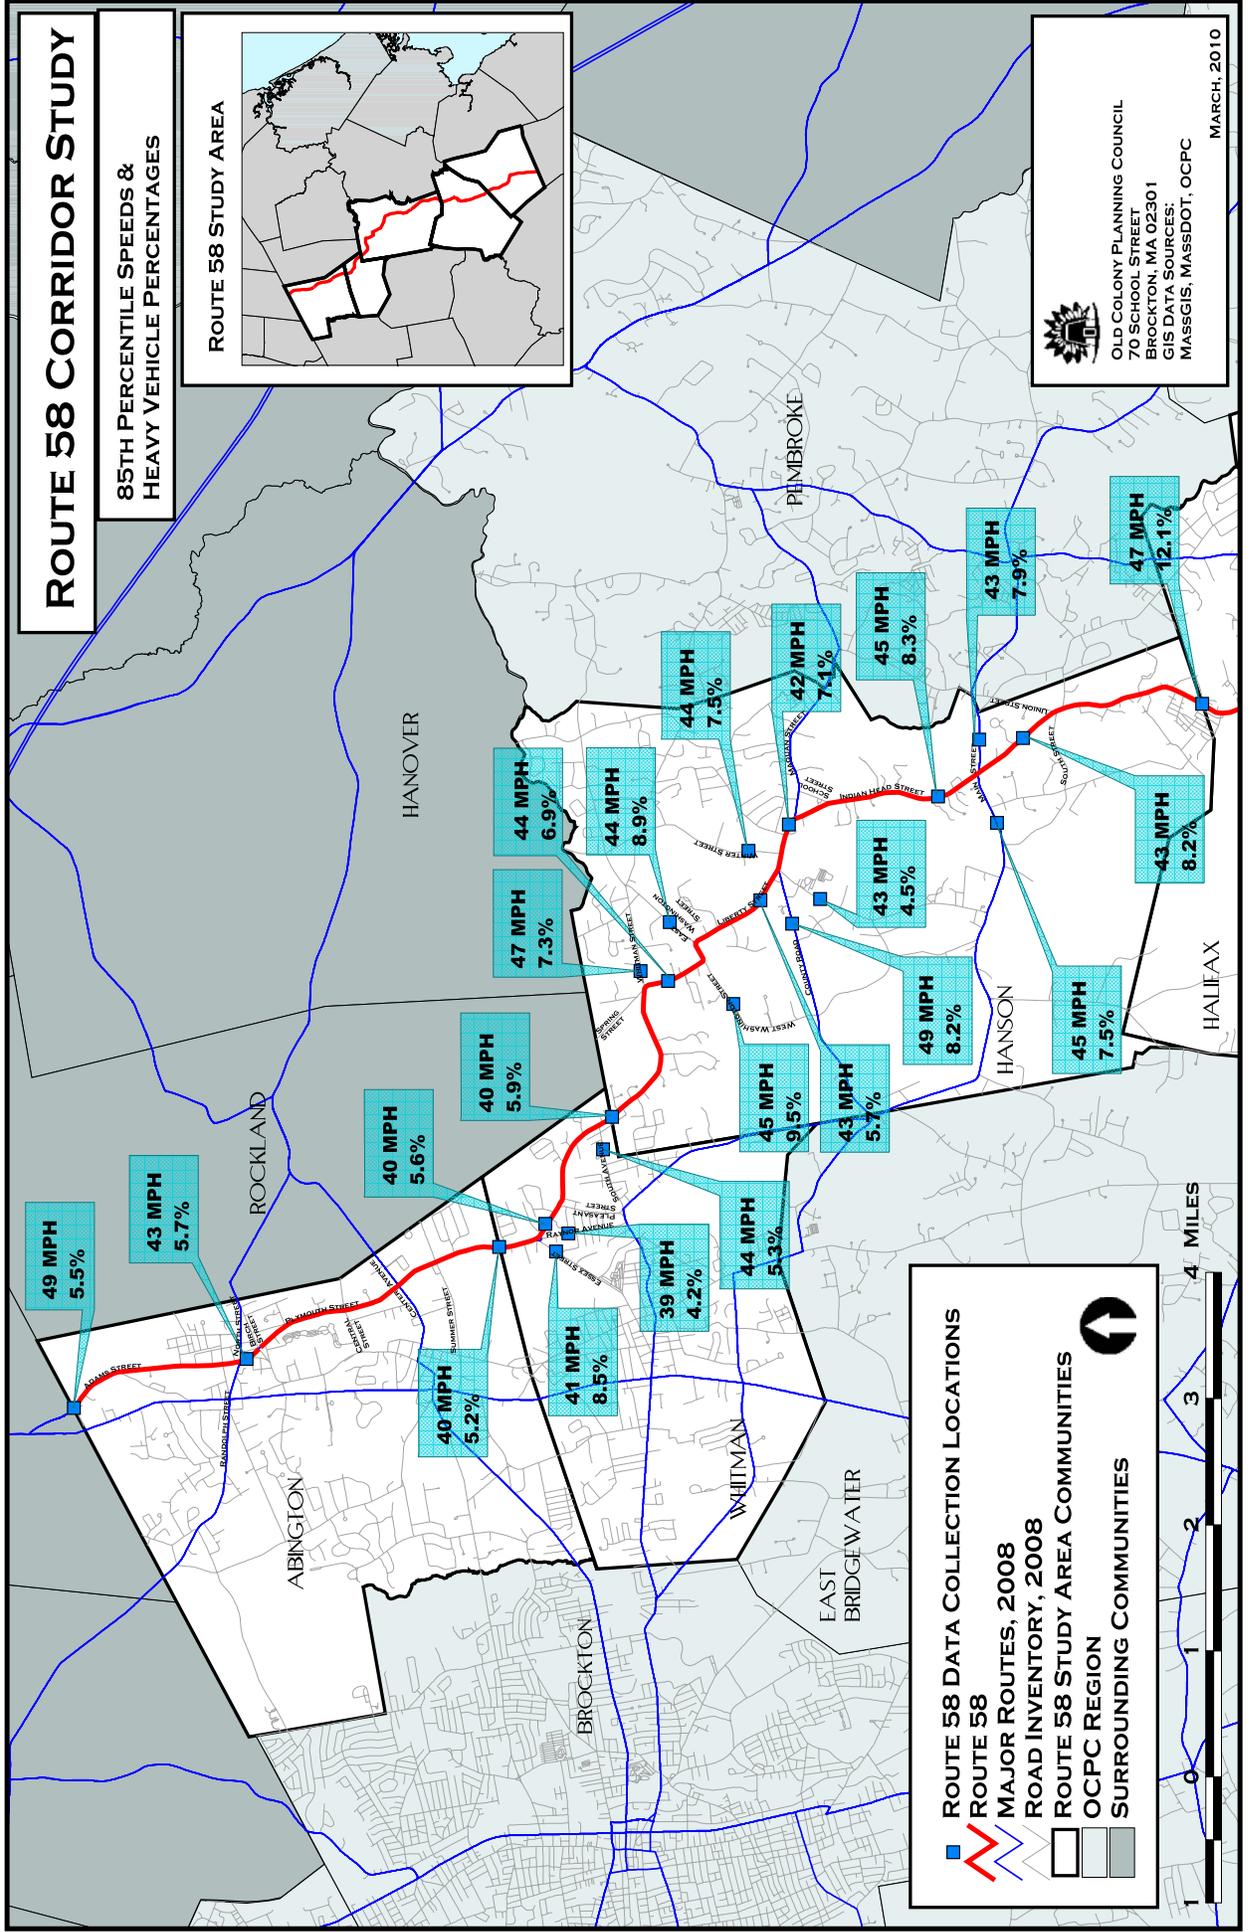
85TH PERCENTILE SPEEDS &
HEAVY VEHICLE PERCENTAGES

ROUTE 58 STUDY AREA

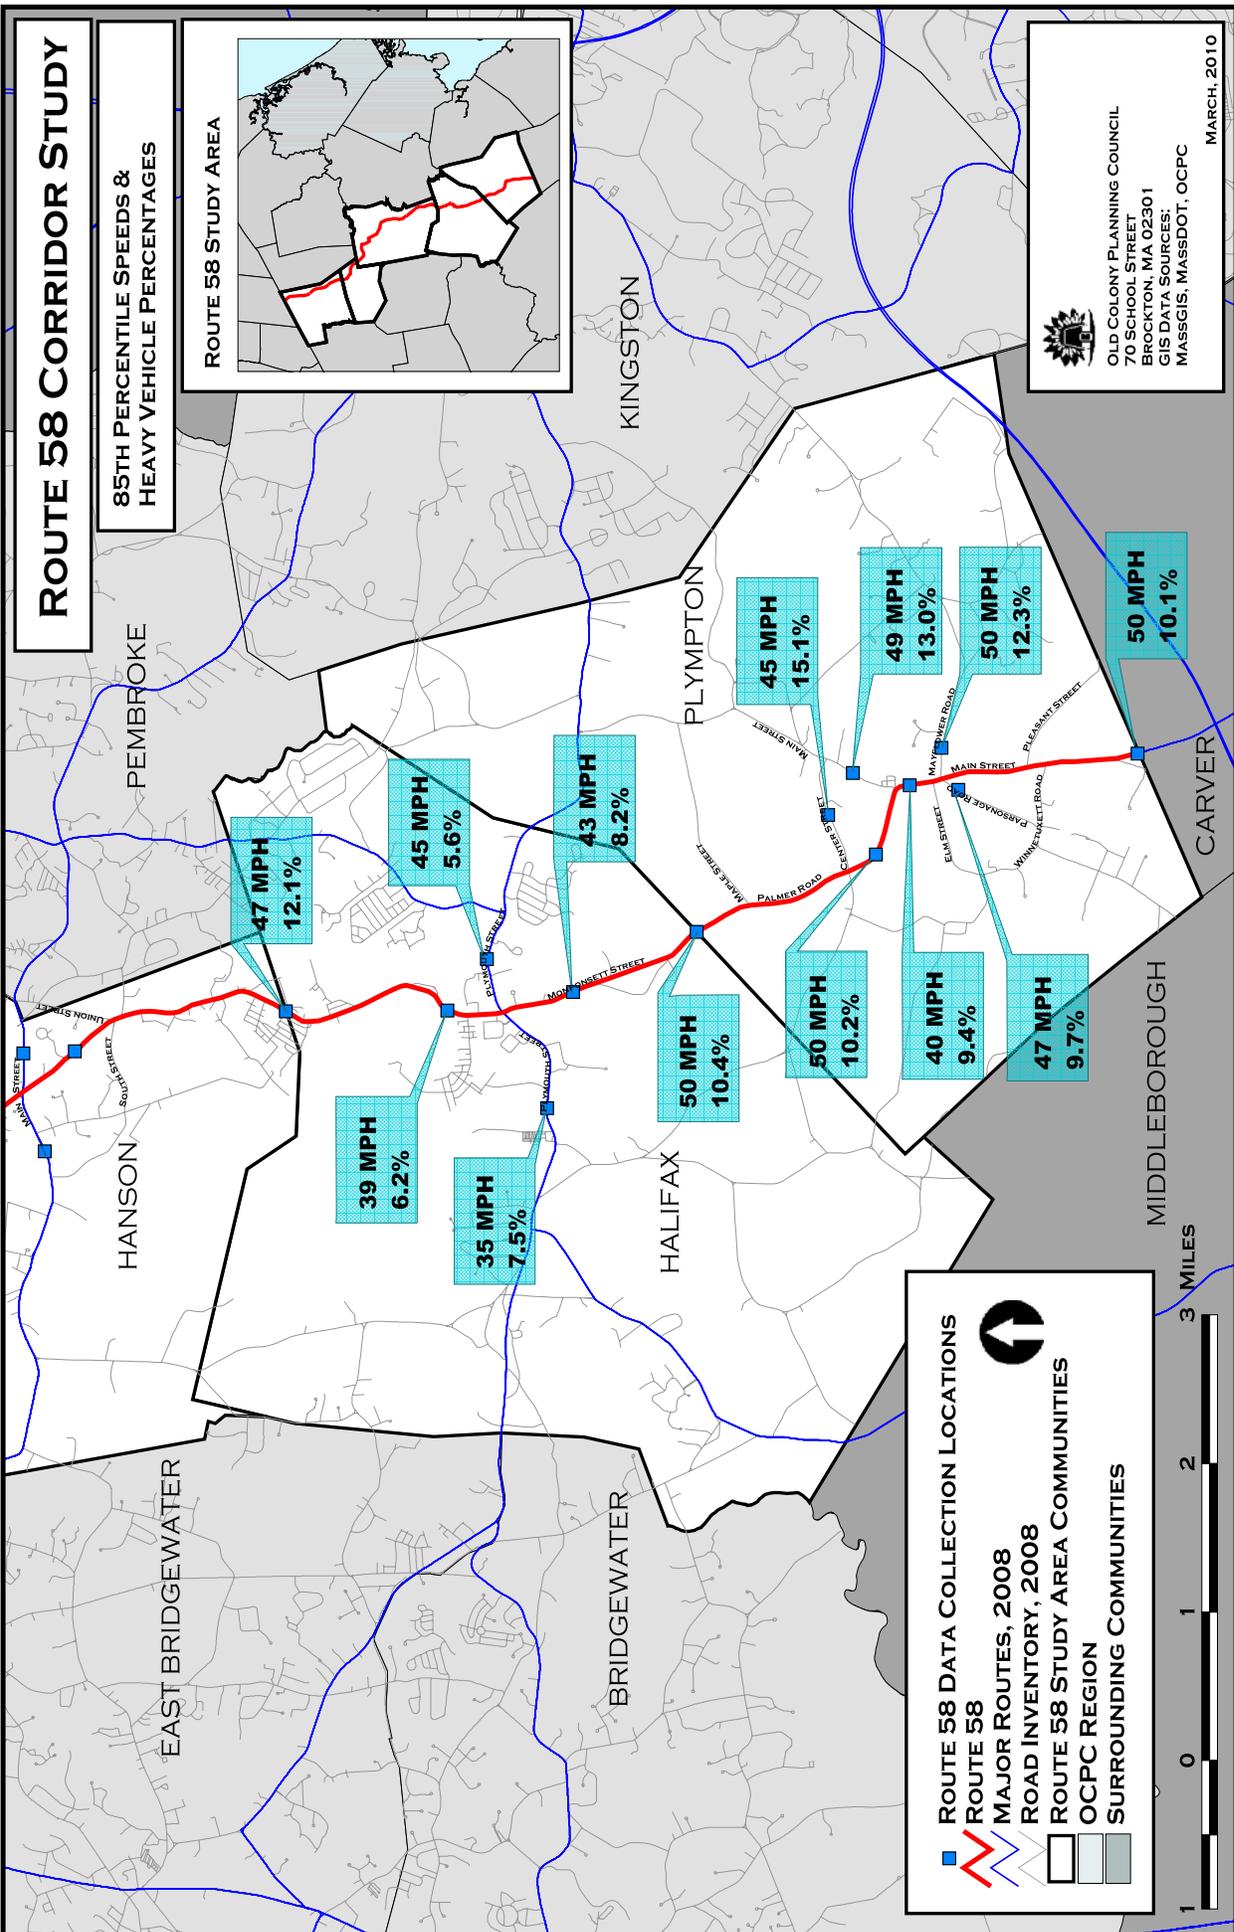
85TH PERCENTILE SPEEDS & HEAVY VEHICLE PERCENTAGES

ROUTE 58 STUDY AREA

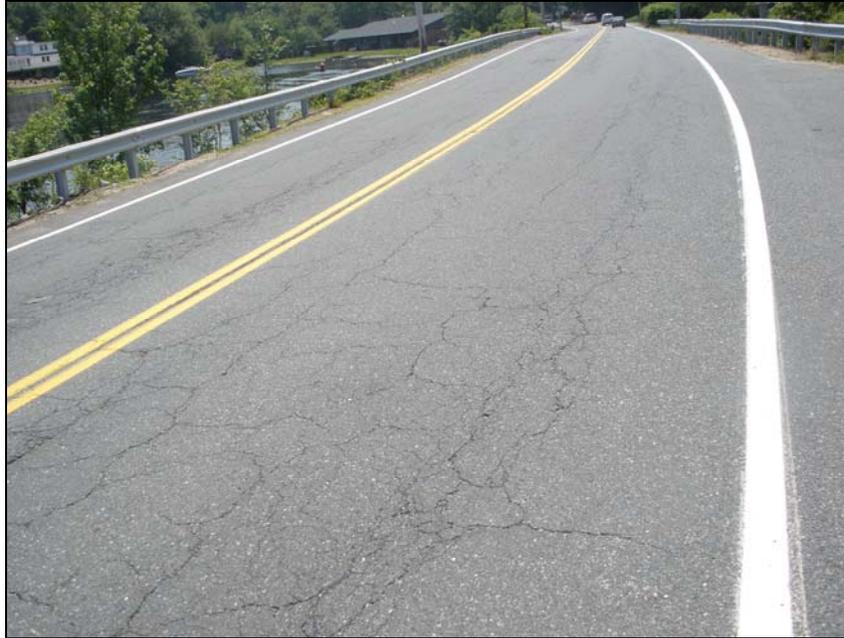
Route 58 pavement conditions in Halifax at West Monponsett Pond and East Monponsett Pond looking north (Poor conditions).

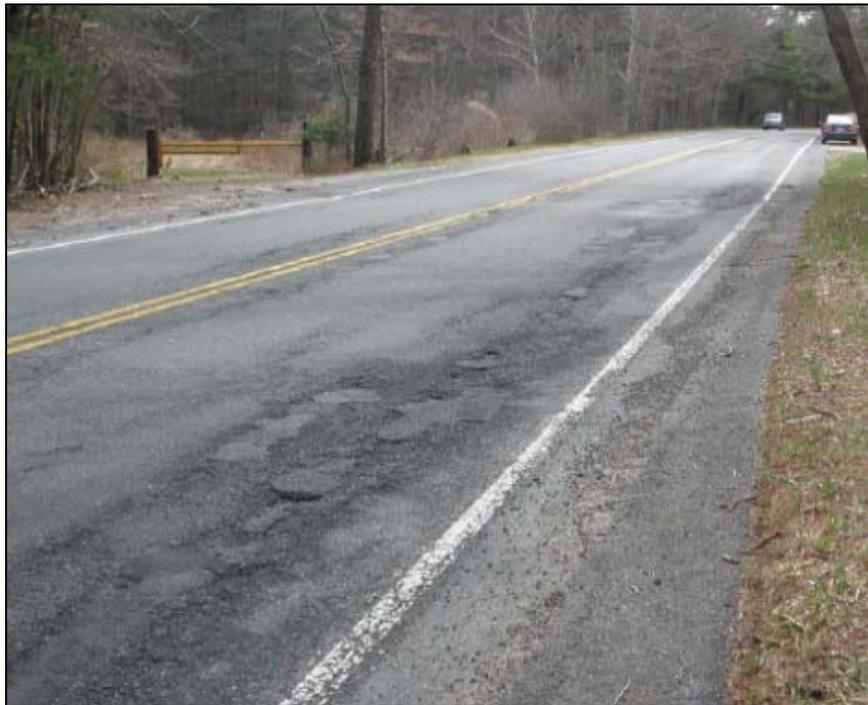
Route 58 Pavement Conditions in Halifax near Palmer Mill Road (Poor conditions).

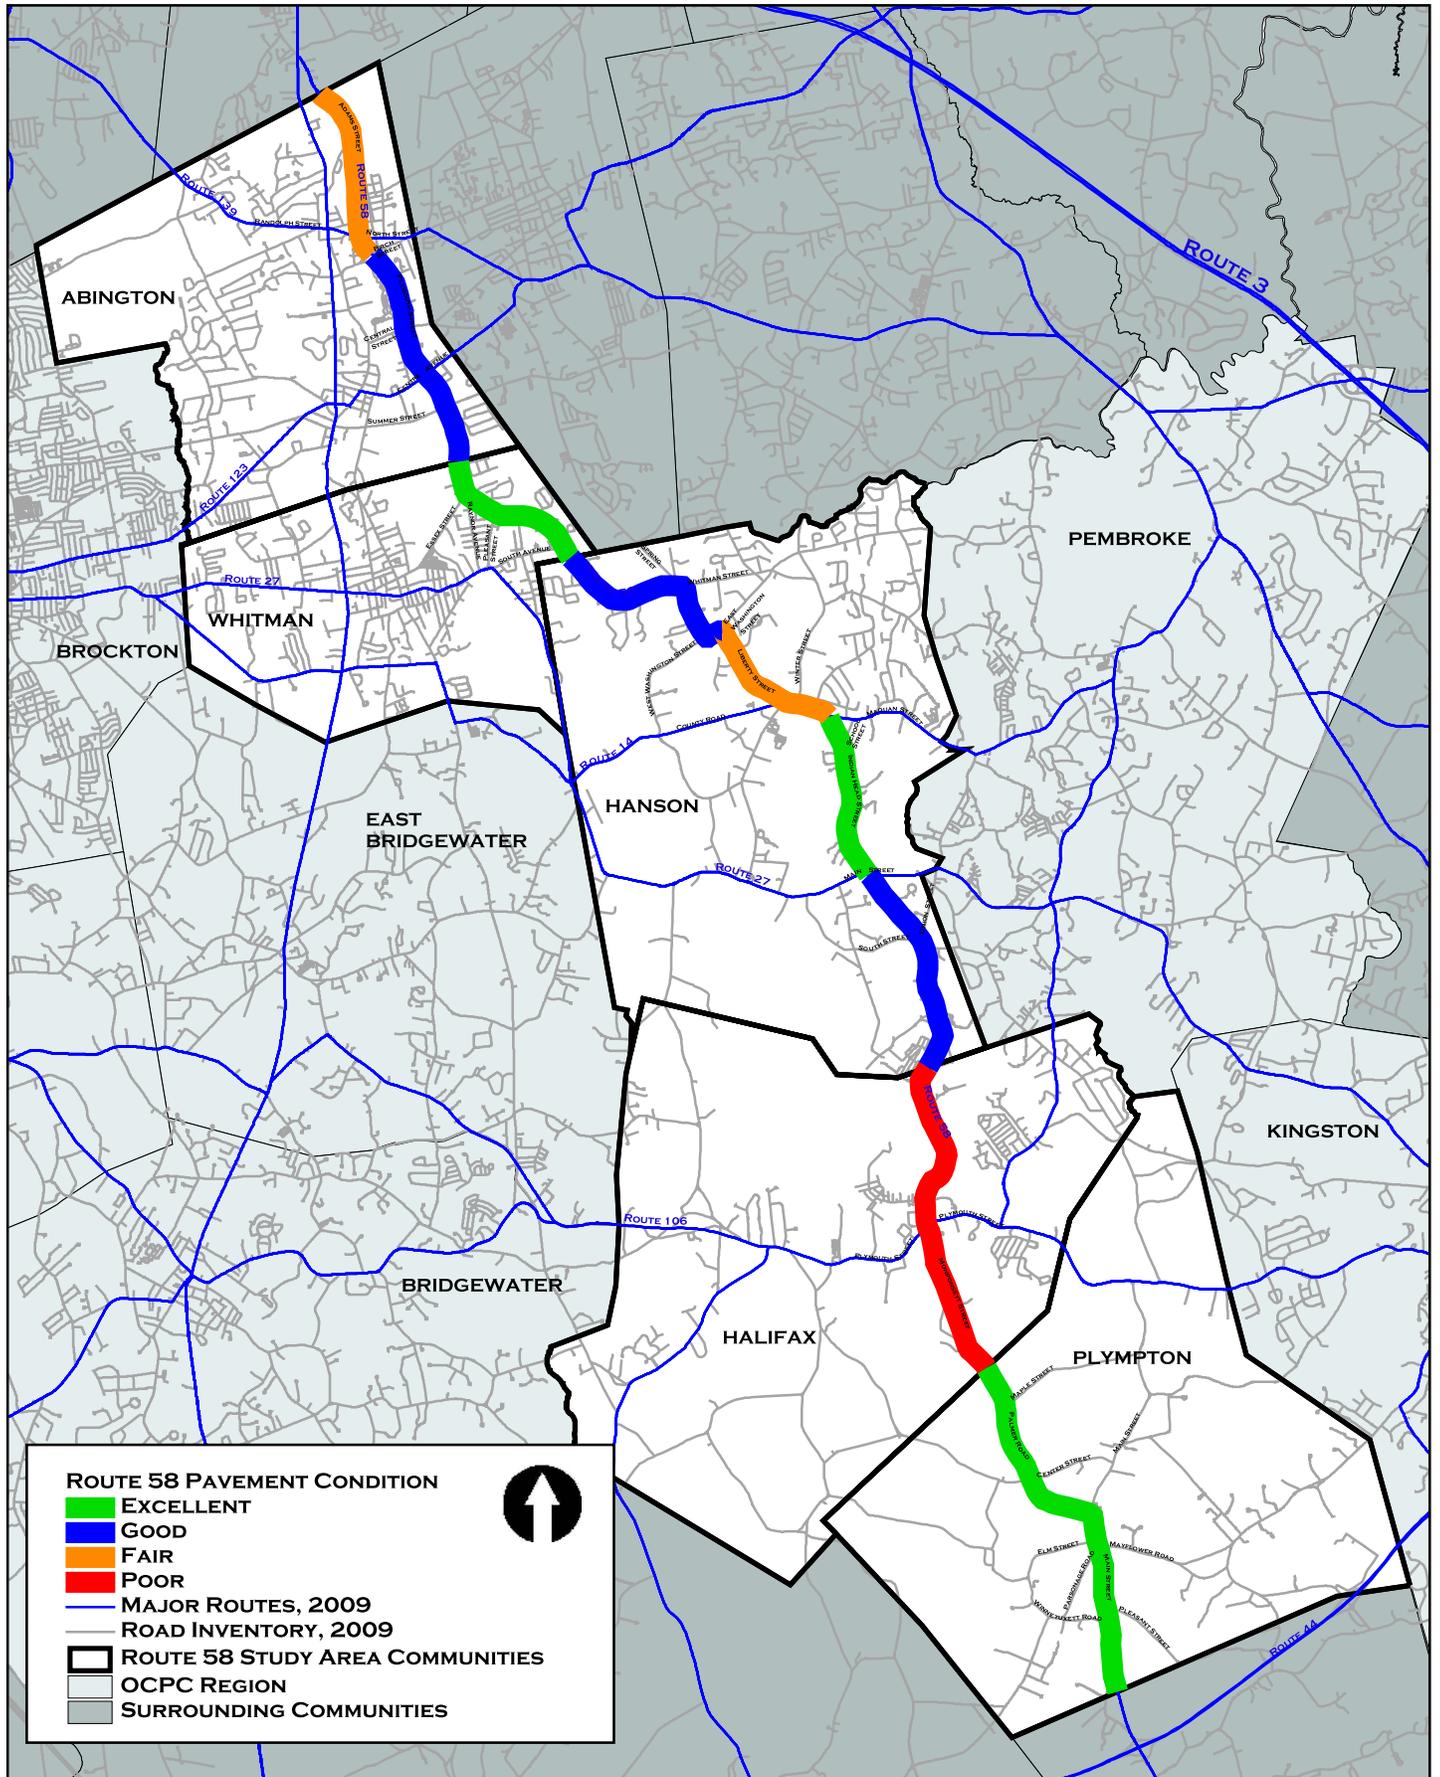
FIGURE 12

ROUTE 58 CORRIDOR STUDY PAVEMENT CONDITIONS

ROUTE 58 PAVEMENT CONDITION

OCPC conducted a windshield survey of the Route 58 corridor to determine the condition of the surface pavement. Figure 12 shows the results of the survey and the road conditions of Route 58 as determined by the software. As shown in Figure 12, the Route 58 corridor in Abington is in “Fair” condition from the Abington/Weymouth Town Line south to Birch Street, and in “Good” condition from Birch Street to the Abington/Whitman Town Line. Route 58 in Whitman is in “Excellent” condition. In Hanson, Route 58 is in “Good” condition from the Whitman Town Line to East Washington Street, in “Fair” condition from East Washington Street to Maquan Street, in “Excellent” condition from Maquan Street to Route 27, and in “Good” condition from Route 27 to the Halifax Town Line.

Figure 12 shows that the pavement on Route 58 in Halifax is in “Poor” condition from the Hanson Town Line to the Plympton Town Line. In Plympton, the Route 58 pavement is in “Excellent” condition as this section of Route 58 has been reconstructed and resurfaced over the past year.

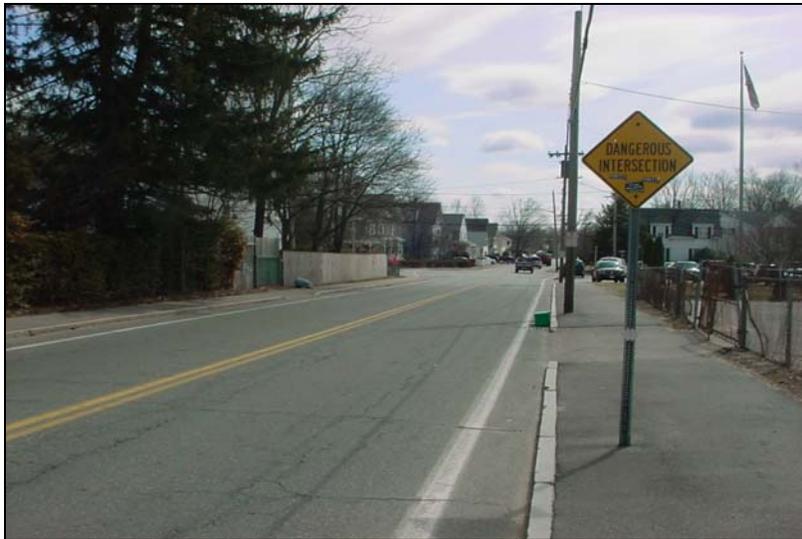
Route 58 in Abington looking south toward Birch Street with sidewalks on both sides of the highway with raised curbs.
