ROUTE 58 CORRIDOR STUDY

INCLUDING THE COMMUNITIES OF: ABINGTON, WHITMAN,
HANSON, HALIFAX, AND PLYMPTON

OLD COLONY PLANNING COUNCIL

SEPTEMBER, 2010

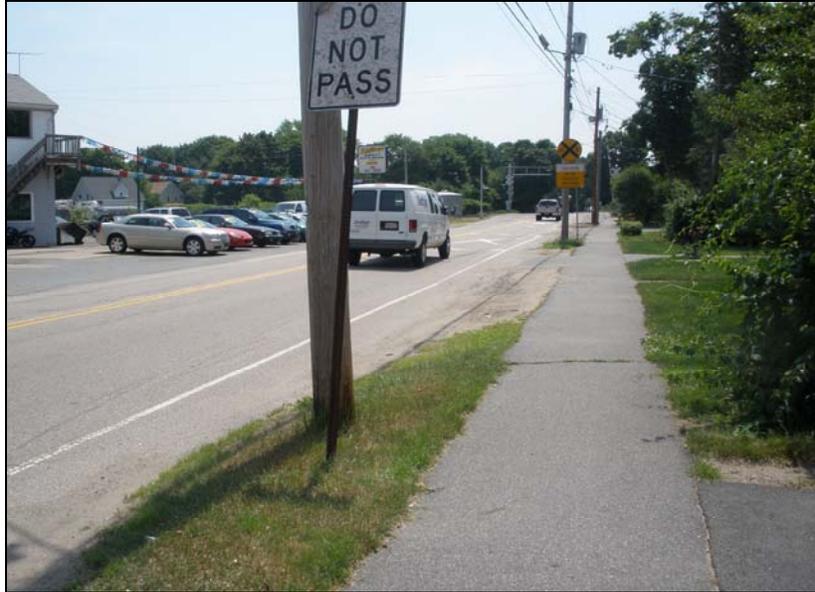
Route 58 in Abington looking south toward the Railroad tracks showing typical sidewalk on the southbound side with a grass buffer but no raised curbs.

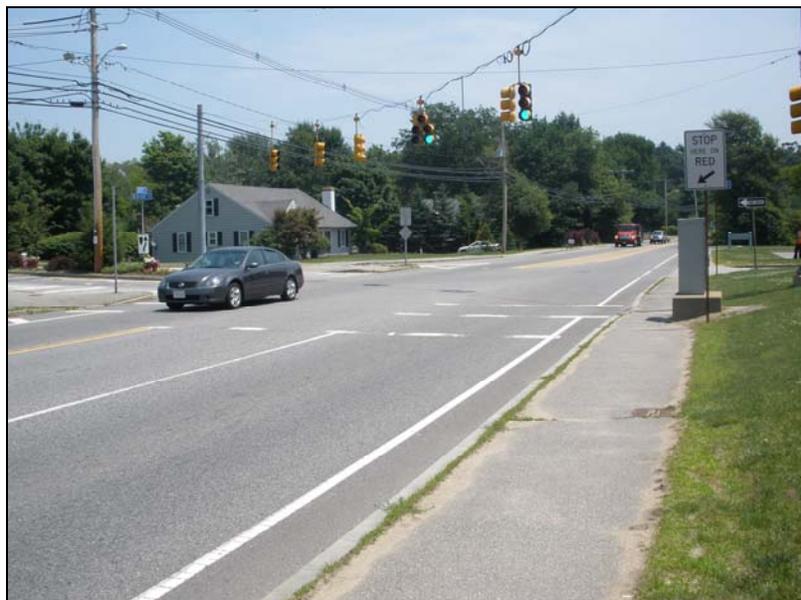
Sidewalks at the Route 58/Winter Street intersection in Hanson looking south.

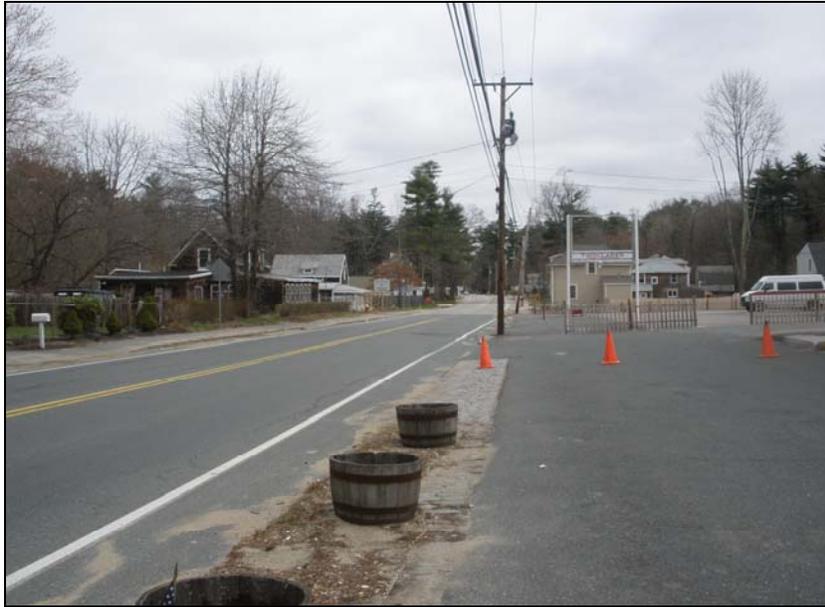
Sidewalks with raised curbs on the southbound side of Route 58 in Halifax at the Hanson Town Line (photo looking north).

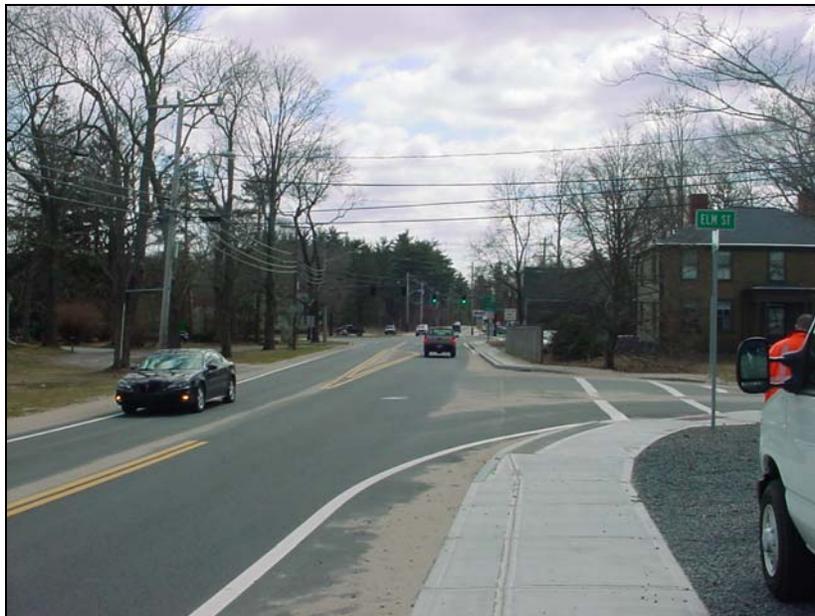
Route 58 sidewalks in Plympton near Elm Street and Parsonage/Mayflower Road

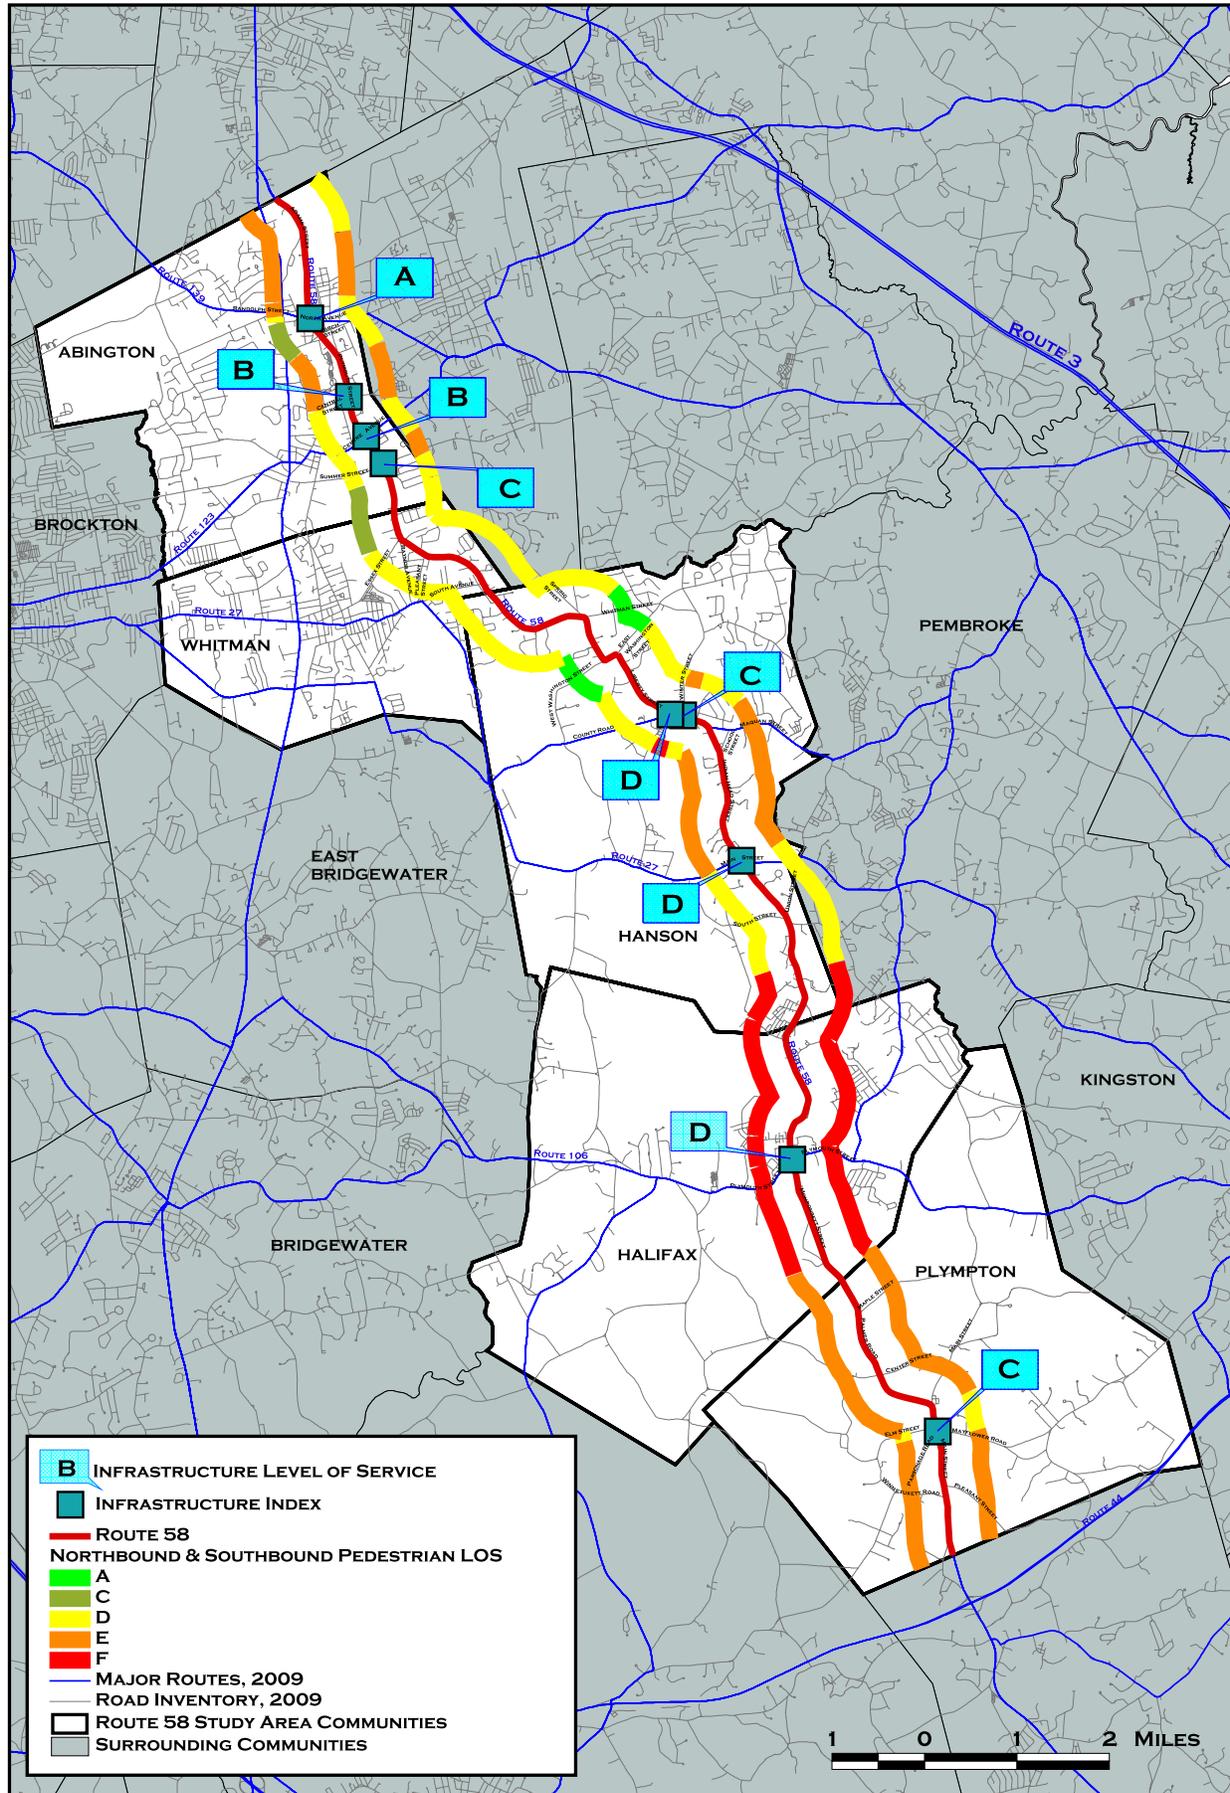
B INFRASTRUCTURE LEVEL OF SERVICE

The pedestrian levels-of-service for Route 58 (including pedestrian LOS at signalized intersections) are shown in Figure 13. In order to identify sidewalk gaps along the corridor, Figure 13 shows the northbound and southbound pedestrian levels-or-service in colored bands parallel to the Route 58 corridor (to the east of Route 58 for the northbound and to the west of Route 58 for southbound). The pedestrian levels-of-service at signalized intersections are also shown in Figure 13 (in callouts blocks). The bicycle levels-of-service for the Route 58 corridor are shown in Figure 14. In Figure 14, the bicycle levels-of-service for northbound are indicated along the east side of Route 58 and the southbound levels-of-service are indicated on the west side of Route 58.

As shown in Figure 13, the pedestrian levels-of-service for most of the Route 58 corridor fall below LOS “C”. In Abington, the portion of Route 58 just north and south of Route 139 provides the highest pedestrian accommodations in the corridor (LOS “B” and “C”). Other portions of Route 58 in Abington that contain LOS “C” accommodations (moderately high pedestrian compatibility) include the portion from Central Street to Centre Avenue (southbound side only). In Whitman, the LOS for pedestrian compatibility is at LOS “D” or below (moderately low to very low compatibility).

Hanson has mostly low levels of pedestrian compatibility, LOS “D” or below, except for two portions on the northbound side; from Route 27 to Maquan Street and from the Halifax Town Line to Briggs Street. Halifax has low levels of pedestrian accommodation, LOS “D” or below, except for the northbound side of Route 58 from East and West Monponsett Ponds to the Hanson Town Line, which is at LOS “C”. In Plympton, the pedestrian LOS is at LOS “D” or below, except for the section of Route 58 from Main Street to Mayflower Road, which is at LOS “C”.

In Abington, as shown in Figure 13, the Route 58/Route 139 intersection has the highest level-of-service (LOS “A” Extremely High Compatibility) compared to the other signalized intersections in the Route 58 corridor. The other signalized intersections in Abington, Route 58 at Central Street, Route 58 at Centre Avenue, and Route 58 at Summer Street, have LOS “C” conditions (Moderately High Compatibility). The Hanson signalized intersections within the Route 58 corridor experience LOS “D” conditions for pedestrian compatibility (Moderately Low Compatibility). The Route 58/Route 106 intersection in Halifax and the Route 58/Mayflower Street/Parsonage intersection in Plympton experience LOS “C” conditions (Moderately High Compatibility) for pedestrian accommodations.

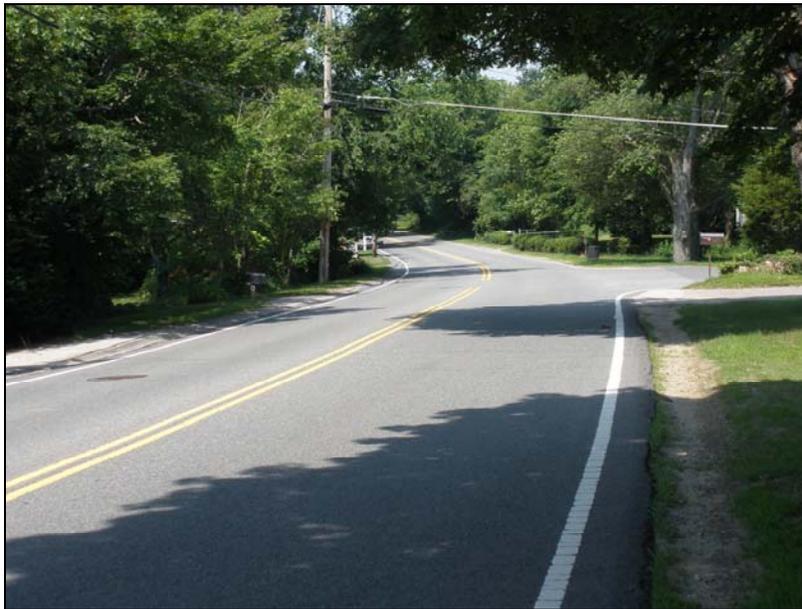
Route 58 in Whitman south of Pleasant Street (LOS “E” bicycle conditions, Very Low Compatibility).

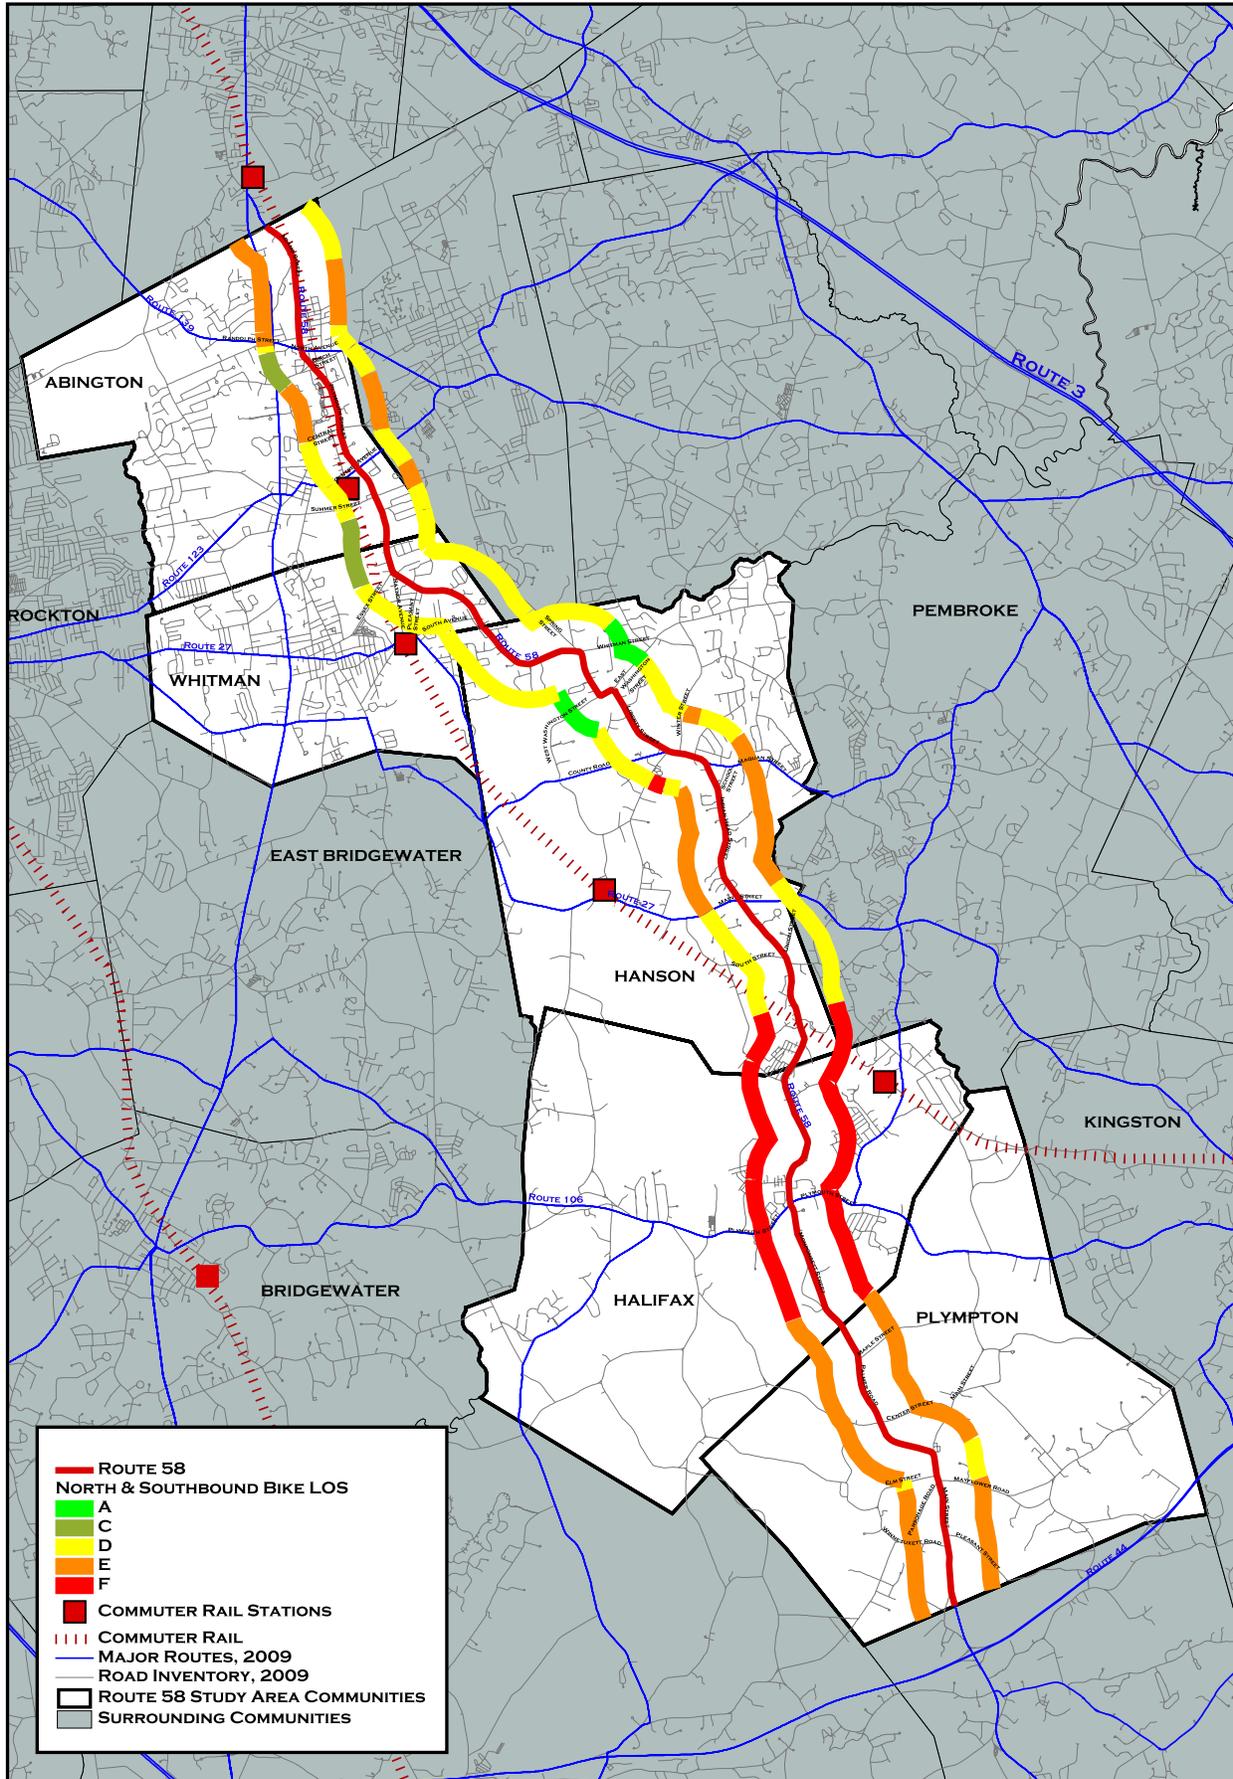
FIGURE 14

ROUTE 58, BICYCLE LEVEL OF SERVICE

Figure 14 shows that most of the Route 58 corridor experiences LOS “D” and “E” (Moderately Low and Very Low) conditions for bicycle compatibility. In Abington and Whitman, the bicycle compatibility is at LOS “D” and “E” for northbound and southbound except for a short section in Abington (from Route 139 to the railroad tracks) and a short section in Whitman and Abington (at the Abington/Whitman Town Line) where the southbound side experiences LOS “C” conditions (Moderately High Compatibility). In Hanson, Figure 14 shows that the bicycle LOS is mostly LOS “D” and “E”, except for a short section from Spring Street to East Washington Street on both the northbound and southbound side where the LOS is at LOS “A” (Extremely High Compatibility). There are also some short sections of Route 58 in Hanson that are at LOS “F” (Extremely Low Compatibility) including southbound from County Road to Winter Street and from Briggs Street to the Halifax Town Line (on both the northbound and southbound sides). In Halifax, the bicycle LOS is at LOS “F” (Extremely Low Compatibility) for most of northbound and southbound Route 58 except for a short section south of Palmer Mill Road to the Plympton Town Line. In Plympton, the bicycle LOS is at LOS “D” and “E” for the northbound and southbound sides (Moderately Low to Very Low Compatibility).

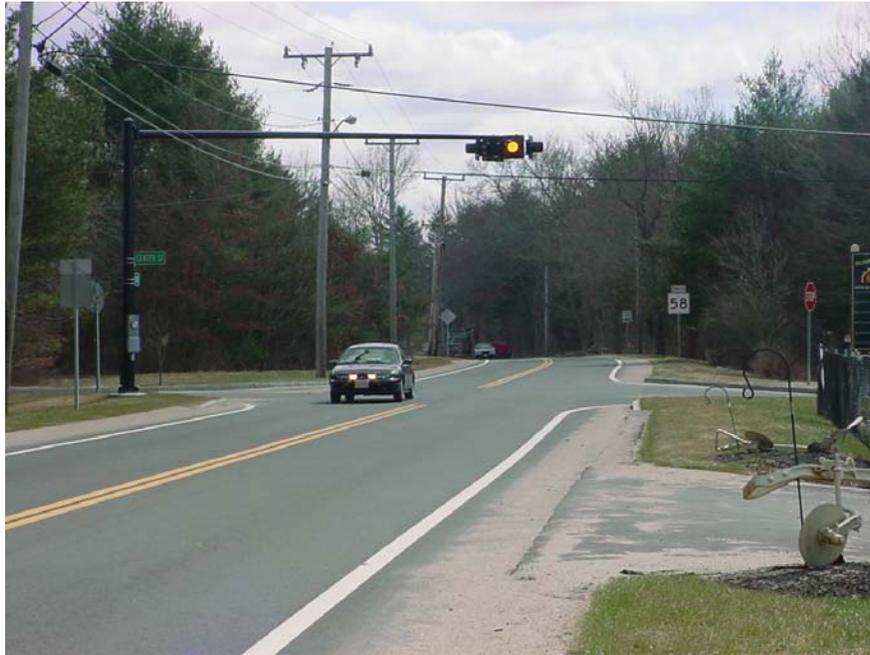
Route 58, Plympton at Center Street showing completed improvements that include re-striping, pavement resurfacing, and installation of a flashing beacon.

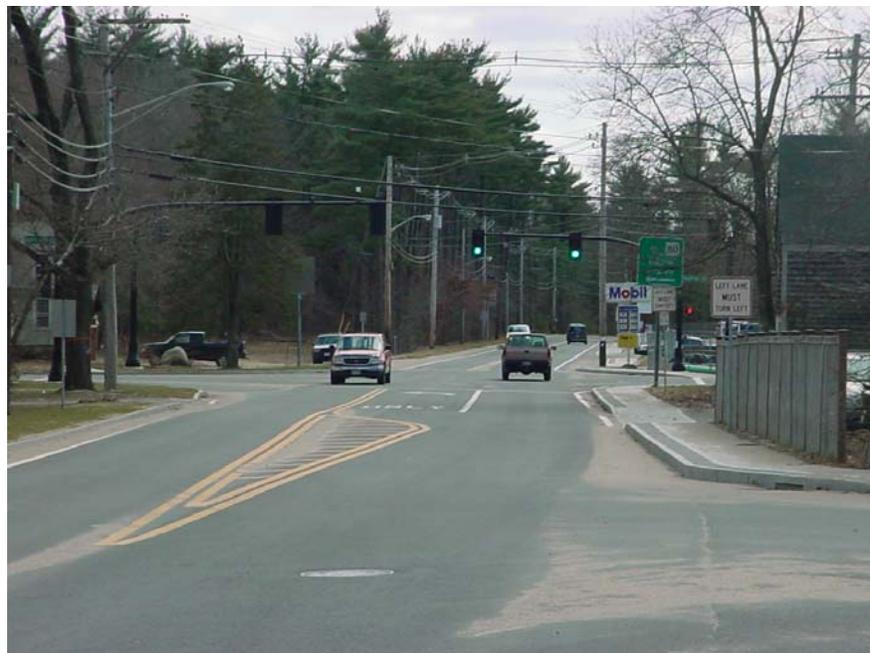
Route 58, Plympton at showing completed improvements for Route 58 that include re-striping, pavement resurfacing, and installation of a traffic signal at the Route 58 Parsonage Road/Mayflower Road intersection.

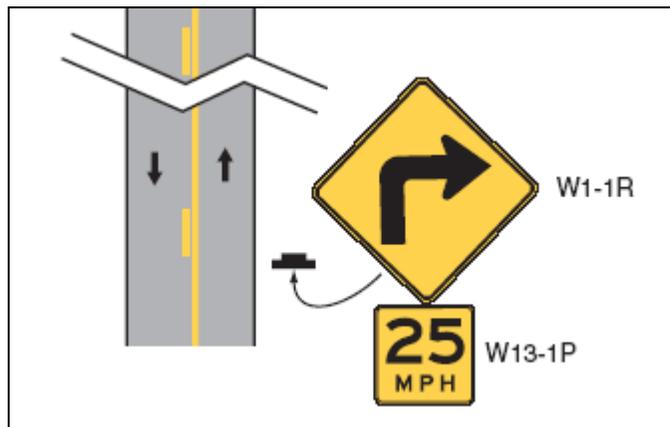
W1-1R and W13-1P, Page 111 of the MUTCD

The reconstruction and relocation of the Spring Street intersection further from the Whitman Street intersection, along with adding a curb and access control at the restaurant opposite Spring Street, were discussed at the stakeholder meetings. Other improvements that are less expensive and short-term should be implemented to improve safety. These include adding advanced warning signs for turns and 25 miles per hour advisory speeds (MUTCD W1-1R and W13-1P, Section 2C.07, page 111) on the northbound and southbound approaches on Route 58 to these intersections.

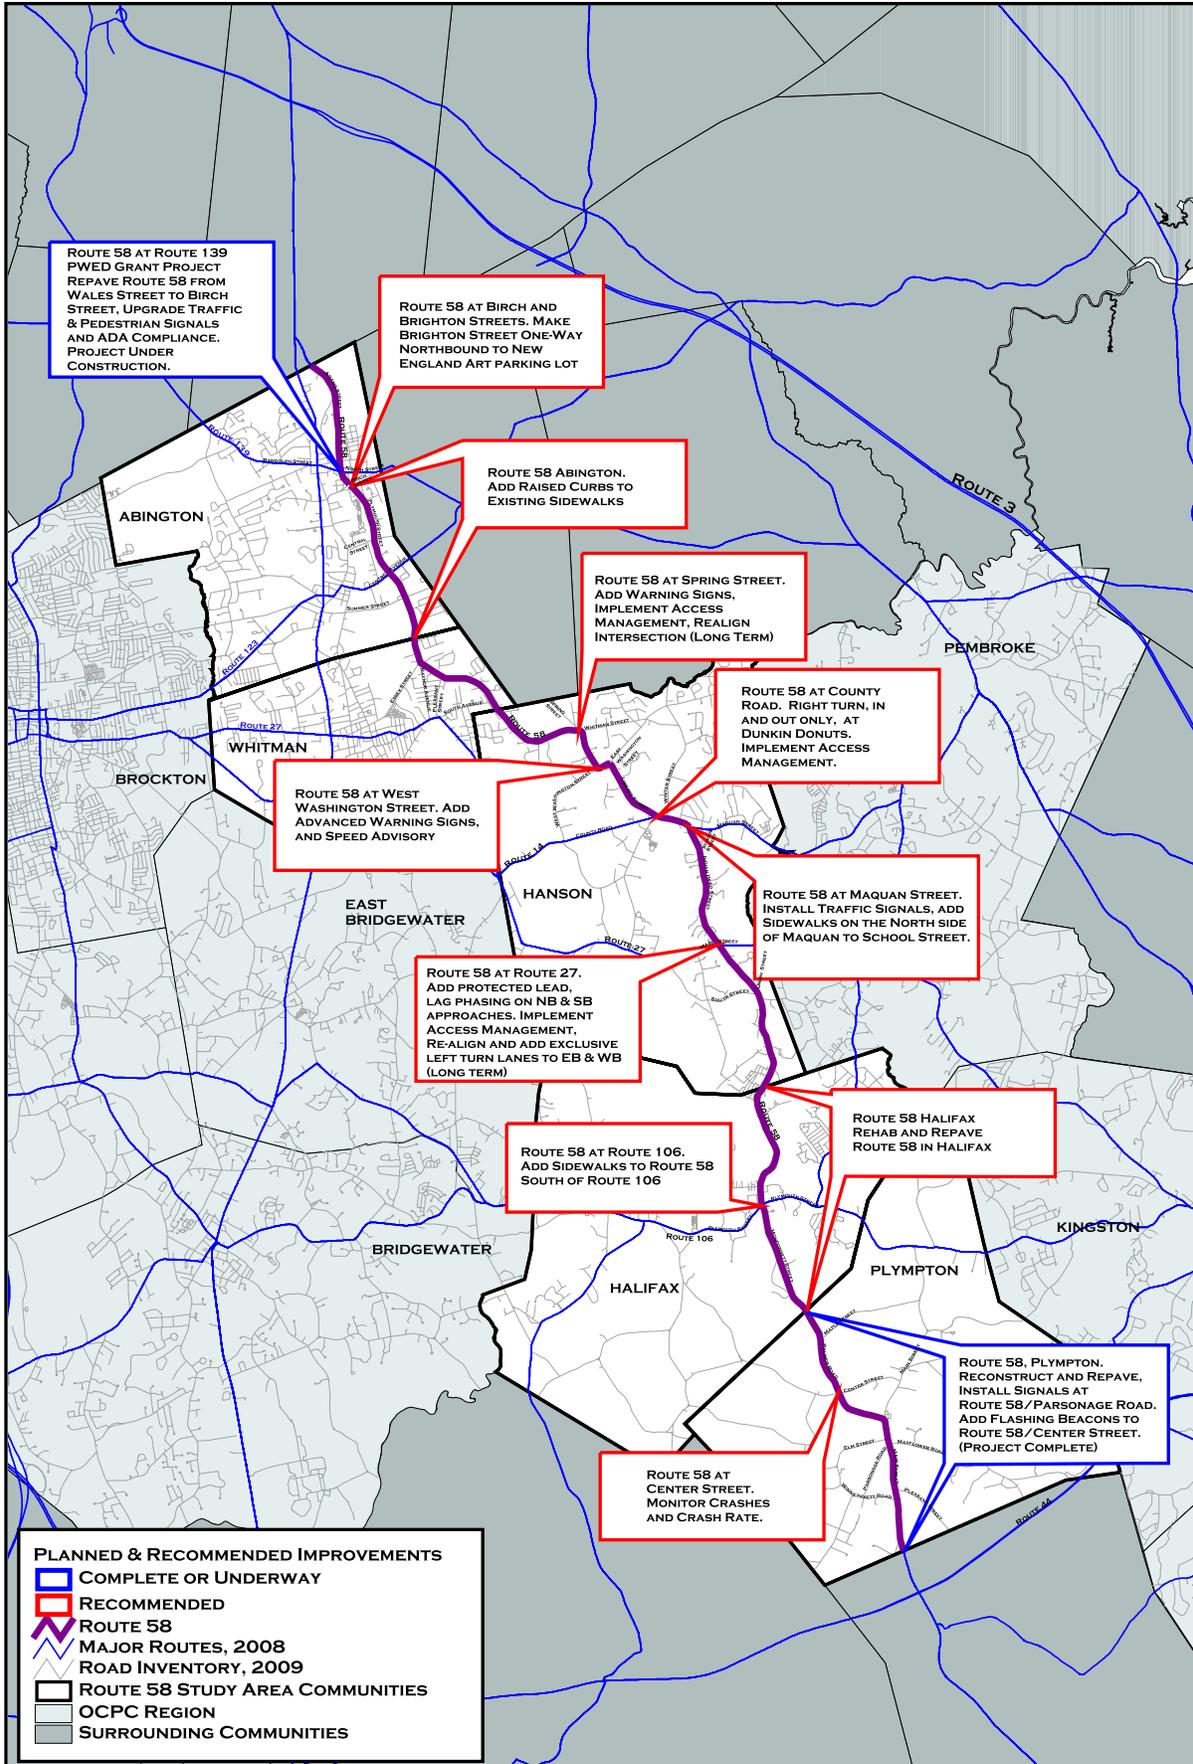
FIGURE 15

PLANNED & RECOMMENDED IMPROVEMENTS
